Navajo Abandoned Uranium Mine

Site Screen Report

Plot 2 AUM Site

August 2010

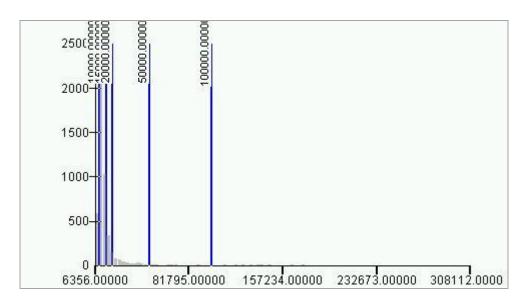
Distribution Chart and Statistics:

The following chart and statistics were generated by ESRI ArcGIS 9.3.1, and show the general distribution of the site gamma radiation measurements. The horizontal X axis represents the gamma radiation reading levels in cpm (lowest levels to the left). The vertical Y axis represents the frequency of each gamma radiation level.

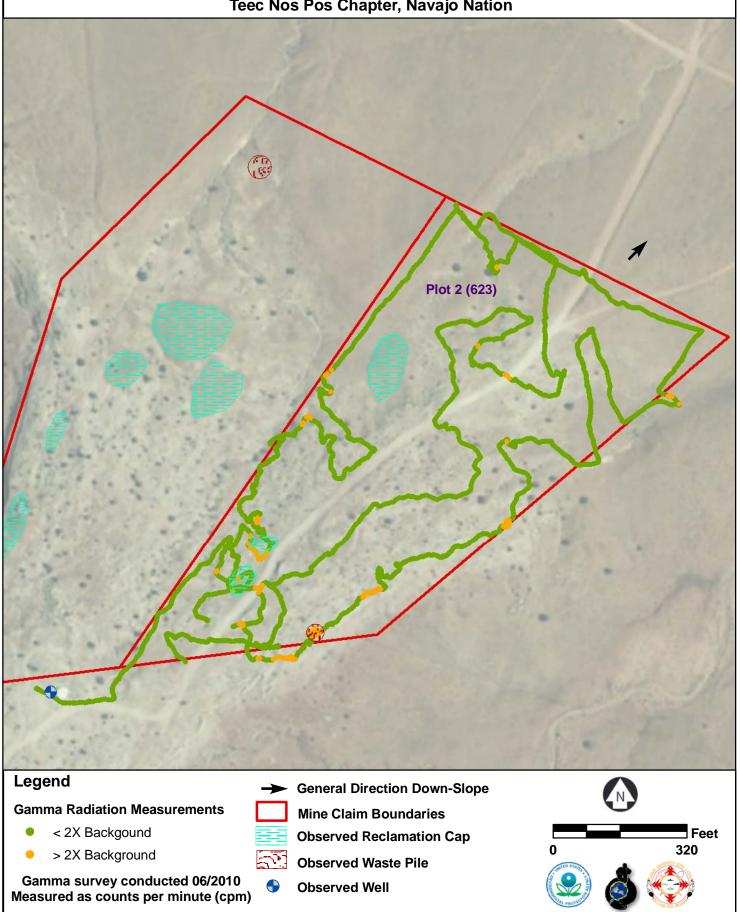
Figure 1 - Gamma Radiation Measurements, Above Two Times Background
Plot 2 (623)
Teec Nos Pos Chapter, Navajo Nation

A total of 5,091 gamma radiation measurements were collected from the mine site, ranging from 6,356 cpm to 308,112 cpm. Measurements collected in the vicinity of the waste debris were found at levels up to approximately 300,000 cpm, and at the caps at levels up to approximately 20,000 cpm. The measurements are represented in Figures 1 and 2.
